Strain Rate Effects on the Energy Absorption of Rapidly Manufactured Composite Tubes

Aaron Brighton, Mark Forrest, Mike Starbuck, Donald Erdman and Bronwyn Fox
Journal of Composite Materials 2009 43: 2183 originally published online 5 August 2009
DOI: 10.1177/0021998309344646

ABSTRACT: Quasi-static and intermediate rate axial crush tests were conducted on tubular specimens of Carbon/Epoxy (Toray T700/G83C) and Glass/Polypropylene (Twintex). The quasi-static tests were conducted at 10 mm/min (1.67×10^{-4} m/s); five different crush initiators were used. Tests at intermediate rates were performed at speeds of 0.25, 0.5, 0.75, 1, 2, and 4 m/s. Modes of failure and specific energy absorption (SEA) values were studied. The highest SEA measured was 86 kJ/kg. This value was observed using Carbon/Epoxy samples at quasi static rates with a 45° chamfer initiator. The highest energy absorption for Twintex tubes was observed to be 57.56 kJ/kg during 45° chamfer initiated tests at 0.25 m/s. Compared with steel and aluminium, SEA values of 15 and 30 kJ/kg, respectively, the benefits of using composite materials in crash structures become apparent.

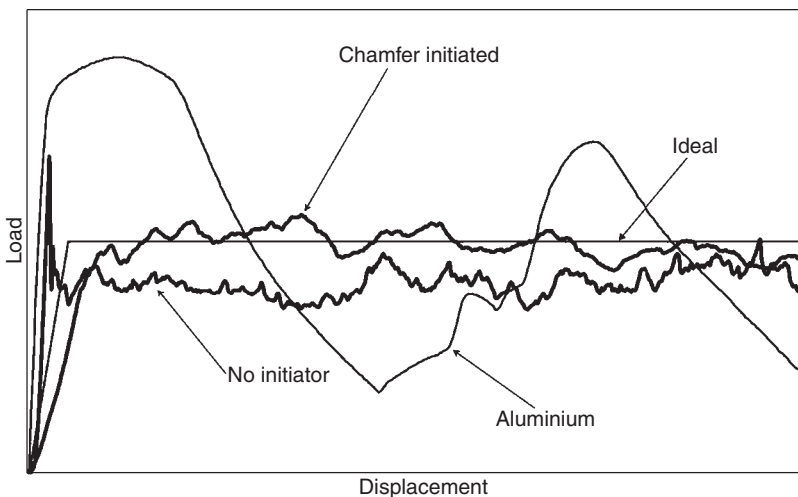
Figure 1. Graph showing the typical response of metallic tubes, composite tubes with and without an 'initiator' and an idealized load line.

Axial crushing of sample tubes has been shown to be representative of the behavior of crash structures in frontal impacts [5]. By definition, the area under a load-displacement curve is the energy absorbed during an event, with a rectangular load-displacement curve representing the maximum energy absorption capability of a material. The progressive crushing of fibre-reinforced plastic tubes approaches this ideal [6] (Figure 1).

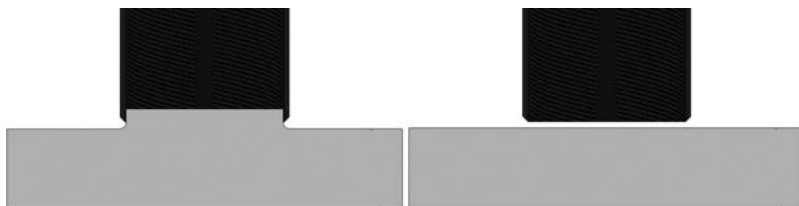
Figure 4. Showing a plug initiator (left) and flat platen (right), both specimens have a 45 Chamfer.

The dynamic tests were performed using a unique purpose built servo-hydraulic test machine built by MTS. Two forms of failure initiation were used, namely the 45° chamfer and the 45° chamfer combined with a 2.5 mm plug initiator (Figure 4). Each initiator type was utilized with both materials at speeds of 0.25, 0.5, 0.75, 1, 2, and 4 m/s. Each of these configurations used three specimens. Ram position, time, load cell (strain gauge load device), and load washer (piezoelectric load device) data were recorded at 4 kHz for the 0.25 m/s tests, 10 kHz for the 0.5 m/s tests and 20 kHz for the 0.75, 1, 2, and 4 m/s tests.

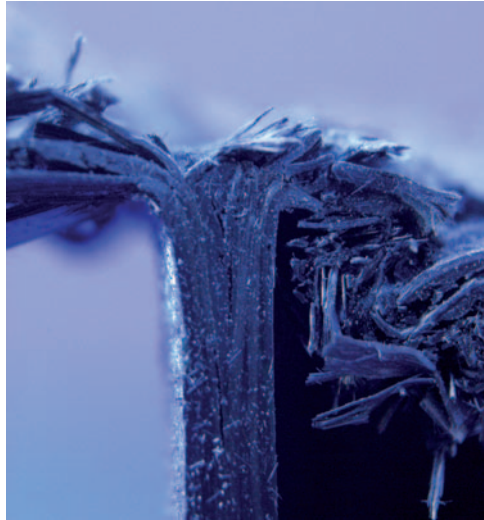
Figure 9. Fracture zone showing failed material and debris wedge in Carbon/Epoxy specimen.

By contrast during the 45° chamfer initiated tests, some of the failed material formed a debris wedge (Figures 8 and 9). This debris wedge caused a mode I interlaminar failure [12]

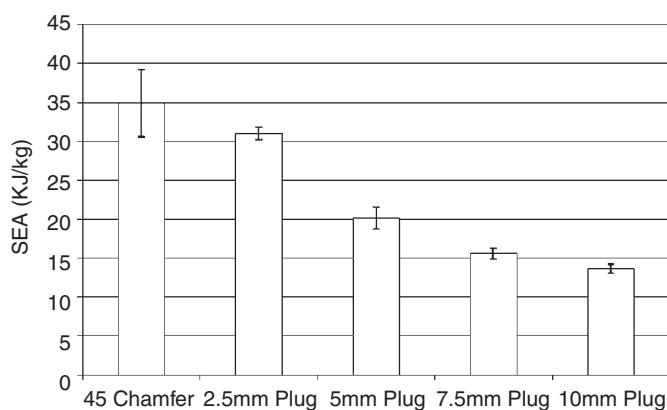
Figure 11. SEA values of Twintex material using different forms of initiation at quasi-static rates showing an increase as the radius of the plug initiator is decreased.

Quasi-static testing of the Glass/Polypropylene tubes produced a similar trend to the carbon. As the radius of plug initiator approached the wall thickness of the specimen, the energy absorbed increased (Figure 11).

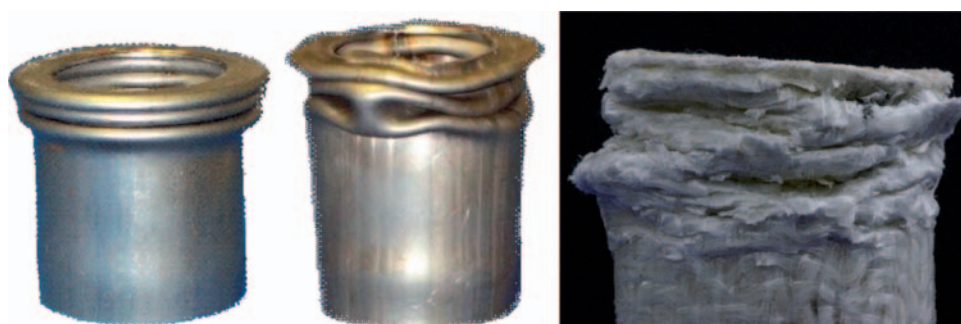
Figure 12. Concertina and diamond crush modes as seen in metallic tubes (left and center) [5] and Twintex tubes (right).

During the quasi-static tests it was observed that the Glass/Polypropylene tubes failed by progressively folding in a combination of concertina and diamond folding. This folding was similar to that observed in the axial crushing of steel and aluminium tubes (Figure 12). When the test speed was increased the Twintex tubes underwent external inversion (Figure 13). This inversion takes place when the material at the fracture zone folds back on itself. As the crush progresses the tube effectively turns inside out. When the failed material comes into contact with the platen it concertinas to allow more material to invert.

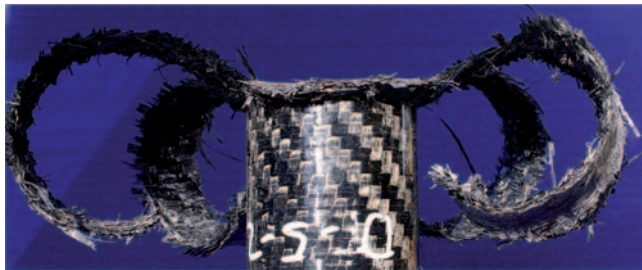
Figure 18. Separated fronds developed in Carbon/Epoxy specimen at 2 m/s impact speed.

As the speed of the 2.5 mm plug tests was increased from 0.5 to 4 m/s, the behavior of the fronds was seen to change. During the 0.5 m/s tests the fronds were found to have a tight radius of curvature (Figure 17), however, at higher crush rates the radius of curvature increased (Figure 18) until the 4 m/s test in which the fronds were not observed to curl much at all (Figure 19).

The radius of curvature of the fronds developed during 2.5 mm plug initiated tests (Figures 17–19) can possibly explain the drop in load as test speed increases. The smaller the radius of curvature of the developing fronds, seen in the 0.5 m/s test, resulted in a larger

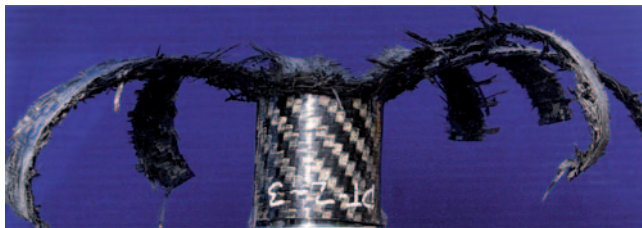
Figure 19. Unwound fronds developed in Carbon/Epoxy specimen at 4 m/s impact speed.
